PUNCH Powertrain

Continuously Variable Transmission

Service Manual VT2-VT3 for Haima ZZ

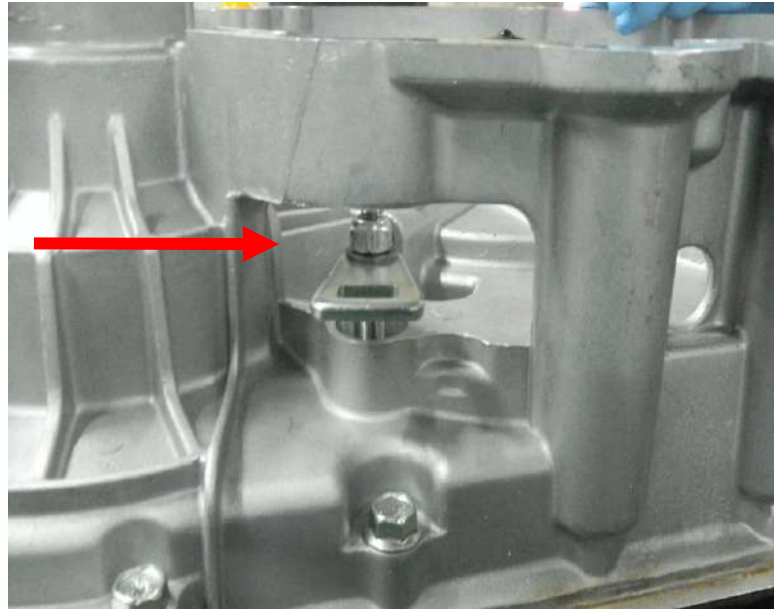
- If the shift lever is not in this position, push the shift lever manually to the outer right position:

Shift lever NOT in P position, NOT OK for cable adjustment

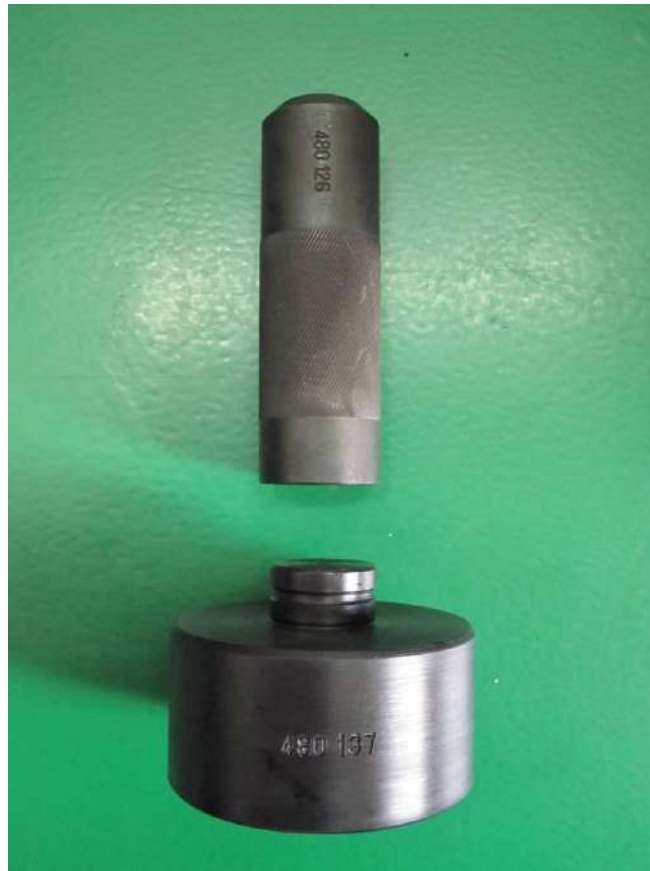
Stamp – Primary bearing (drawing 480137 + 480126)

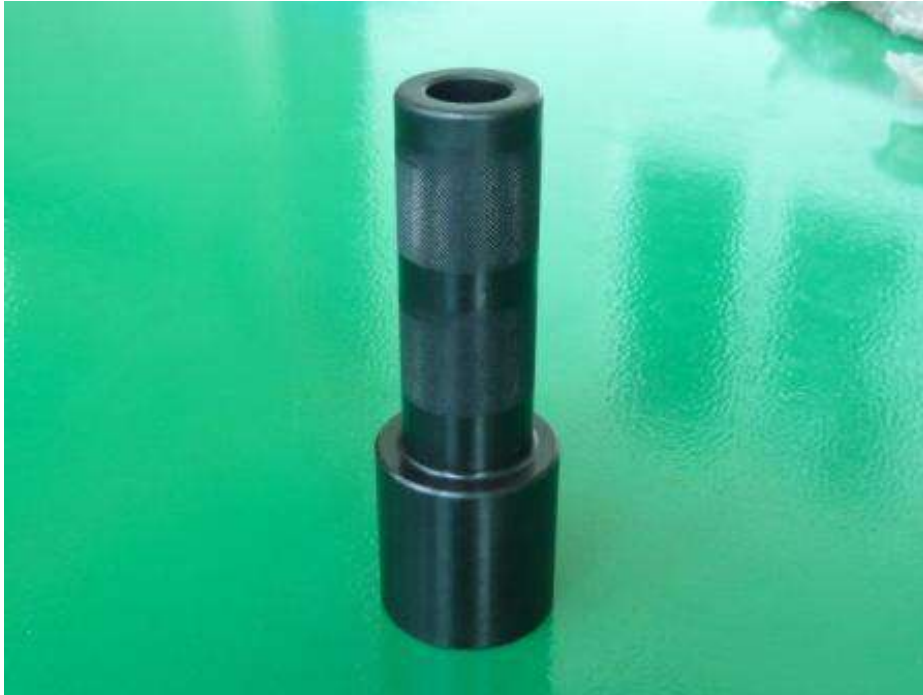
Stamp – oil seal input shaft (drawing 480130)

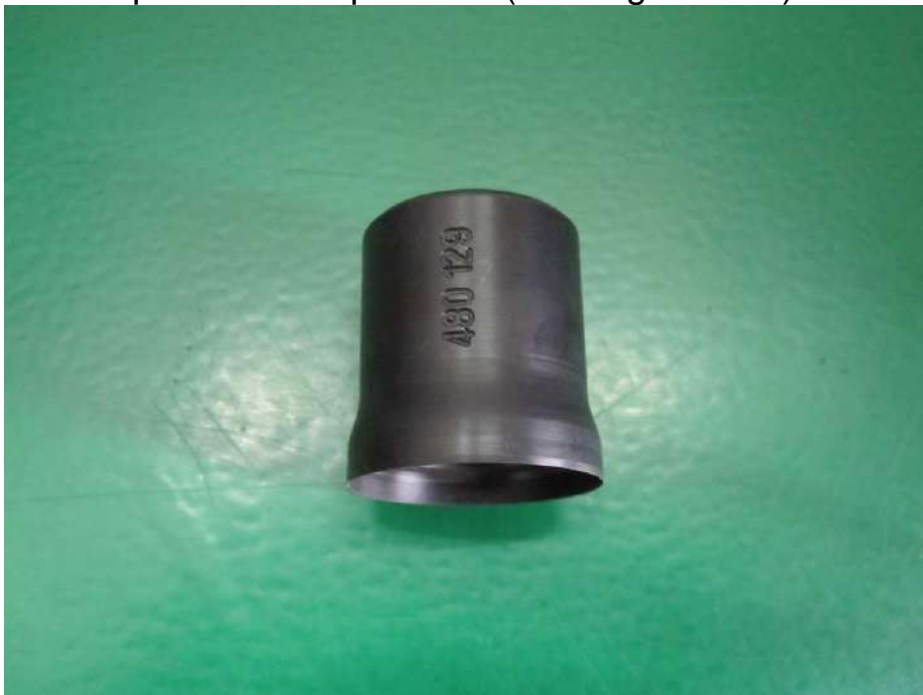
Centering bush – oil seal input shaft (drawing 480129)

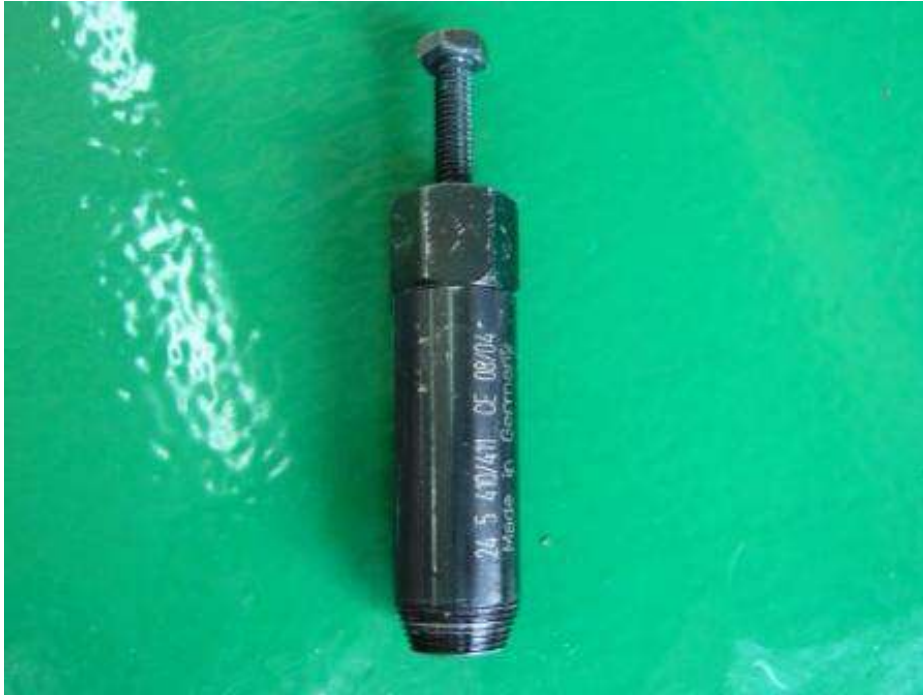
Removing tool – oil seal selector shaft (drawing 480127)

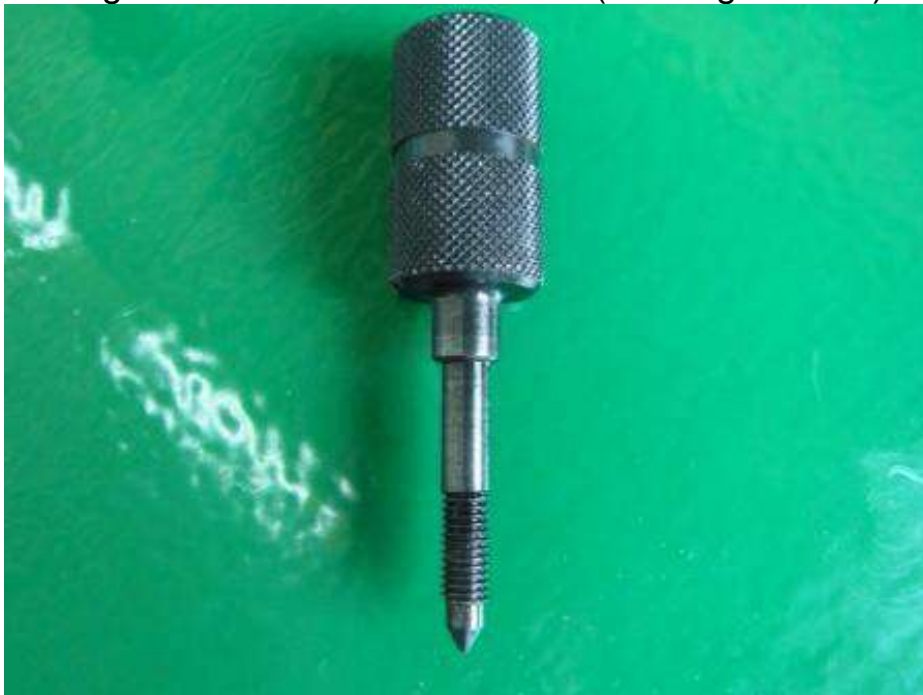
Centering pin – hydraulic unit (drawing 480142)

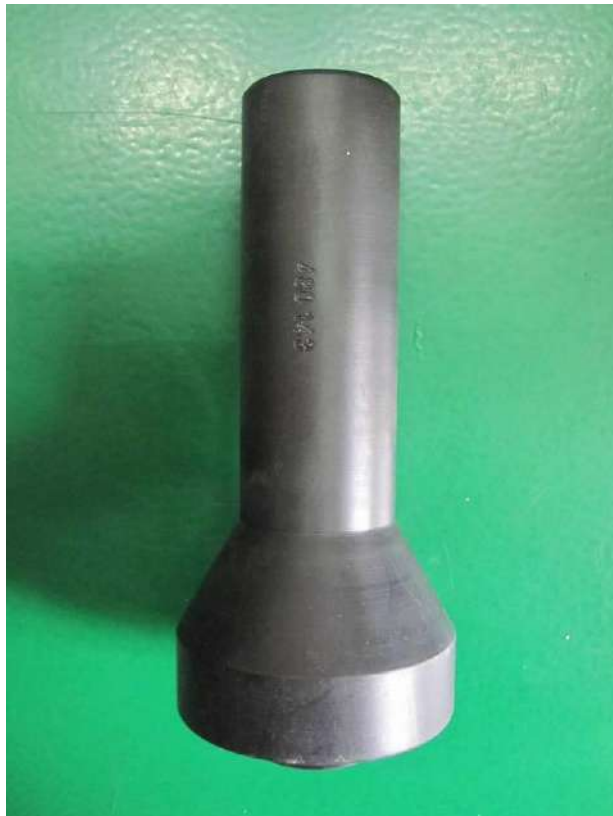
Stamp – oil seal differential (drawing 480143)

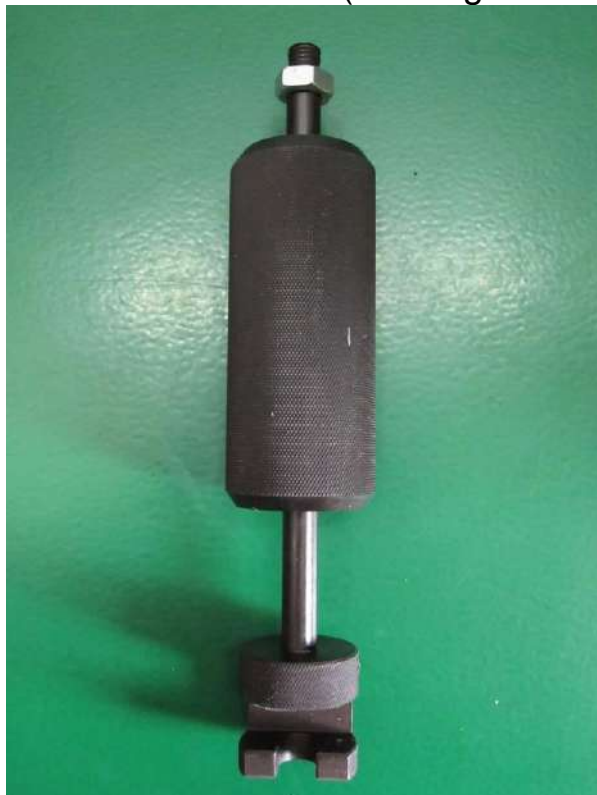
Removing tool – pump (drawing 480141)

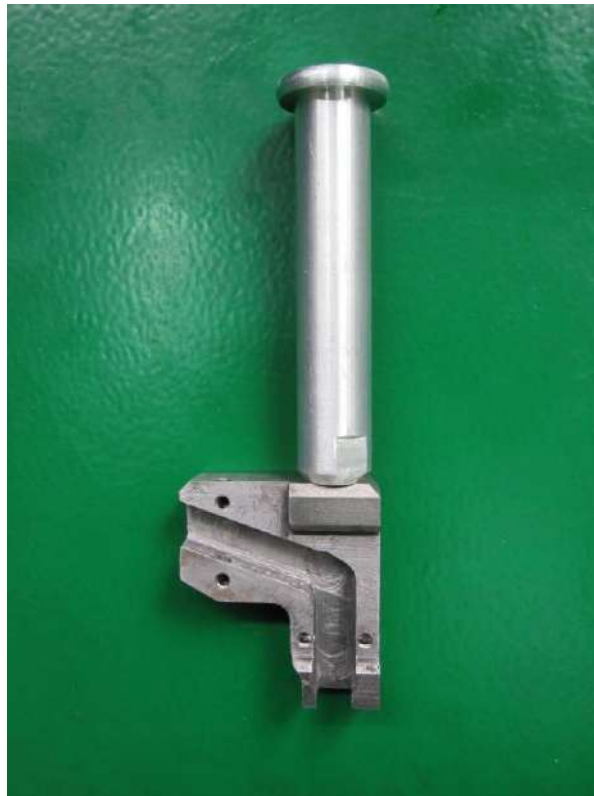
Assembly tool – breather pipe (drawing 480140)

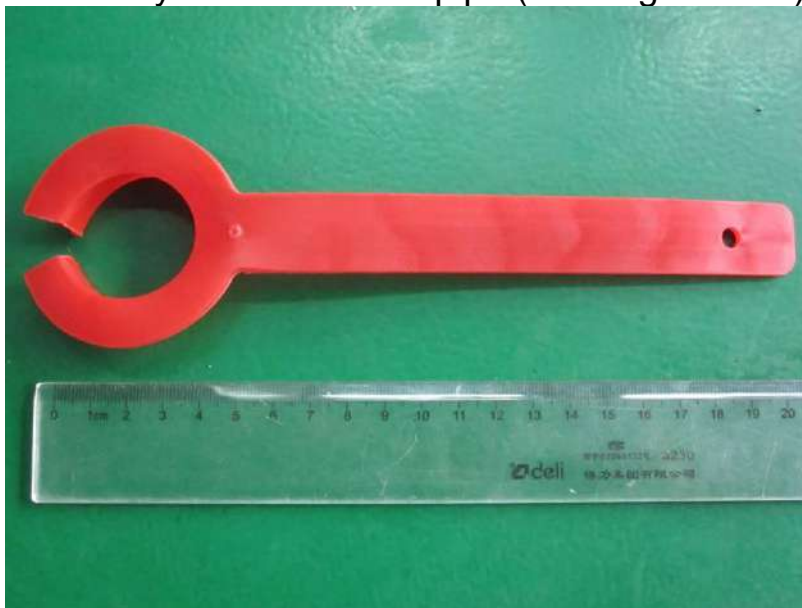
Assembly tool drive shaft (drawing 48154)

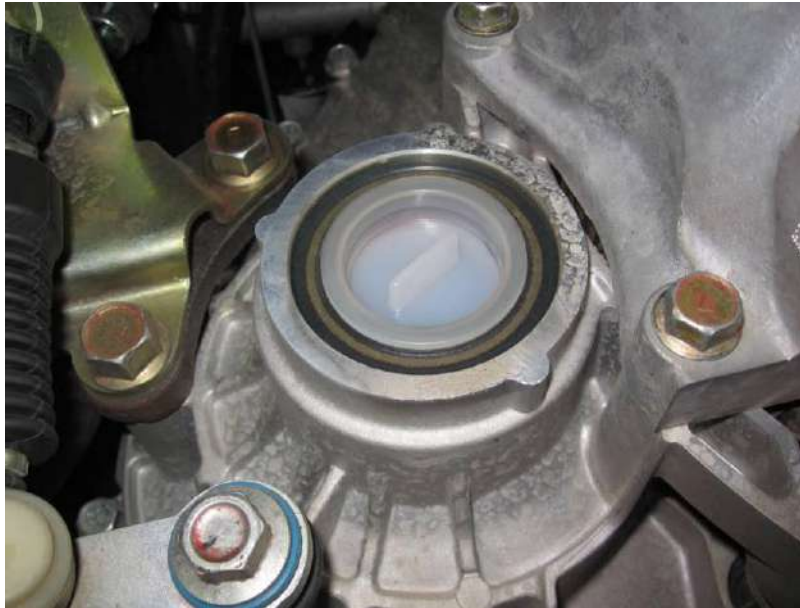
-Remove the protection covers:

Fig. 1-1: Protective covers for differential seal

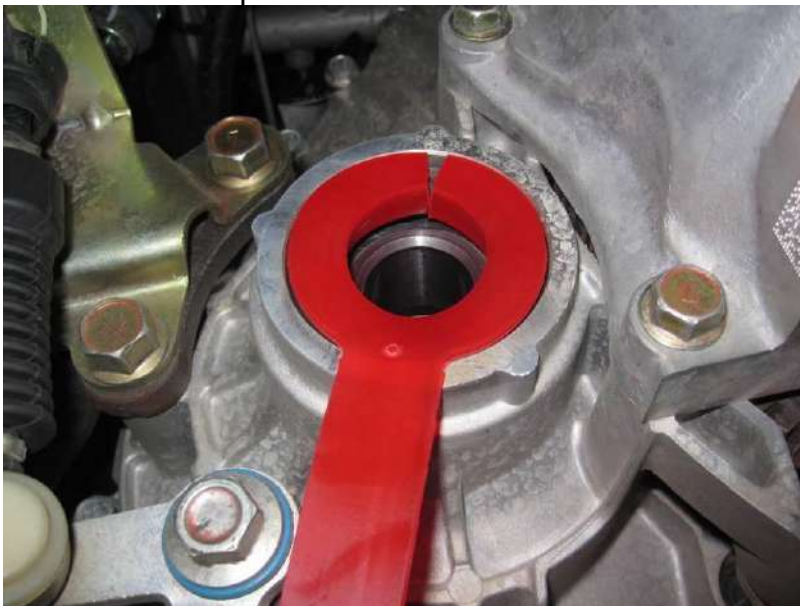
-Install tool 480145 over the output seal:

Fig. 1-2: Assembly tool drive shaft 480145 mounted

During the assembly of the drive shafts into the transmission, we strongly recommend to use Punch Tool 480145 in order to protect the oil seal at the differential.

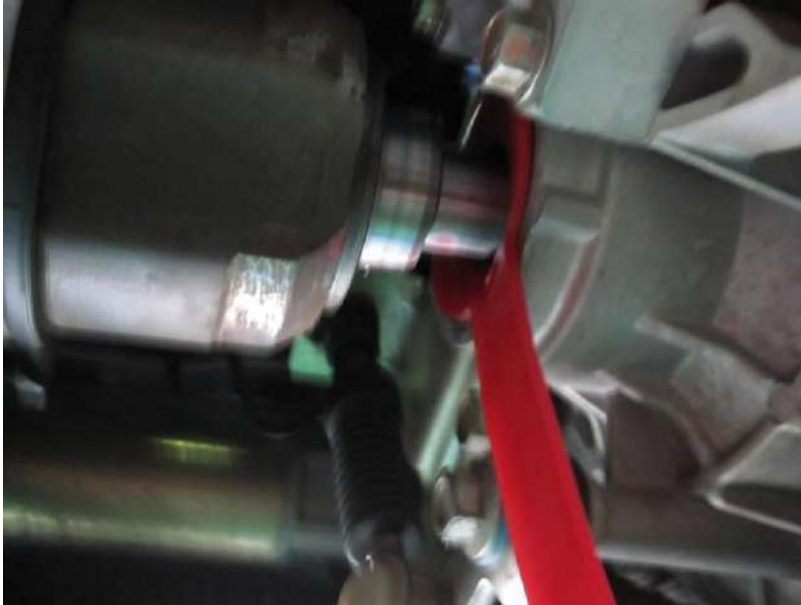
-Insert drive shaft for max 4cm into the transmission:

Fig. 1-3: Drive shaft inserted for 4cm

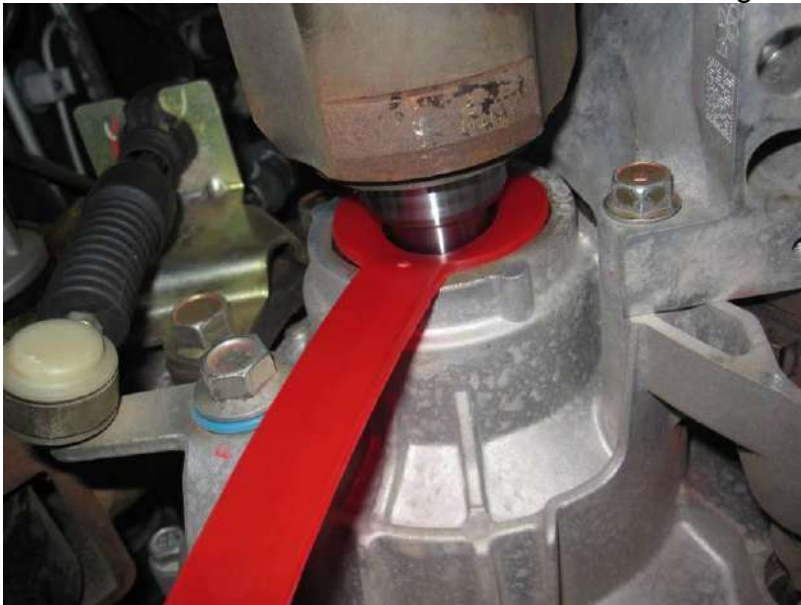
-Stop and leave 2 cm distance between the driveshaft and mounting tool:

Fig. 1-4: 2 cm distance between drive shaft and tool 480145

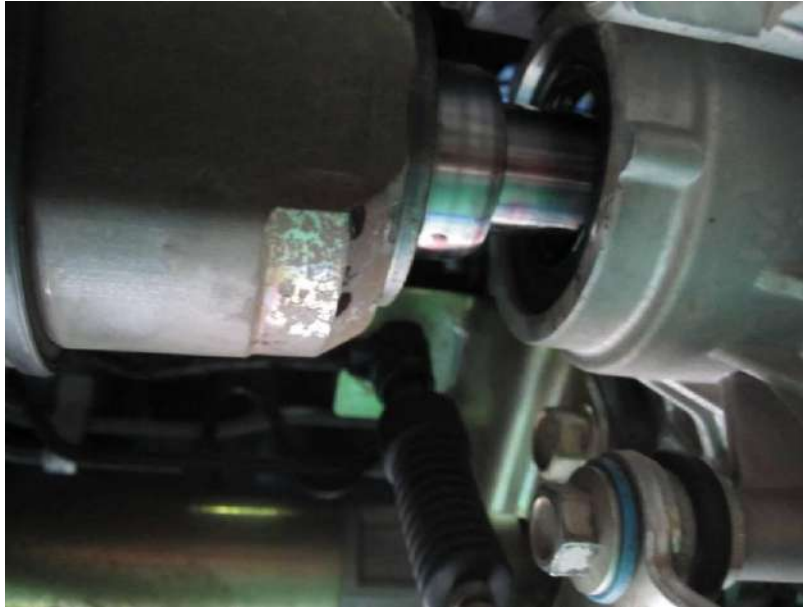
-Remove the tool 480145

Fig. 1-5: Tool 480145 removed

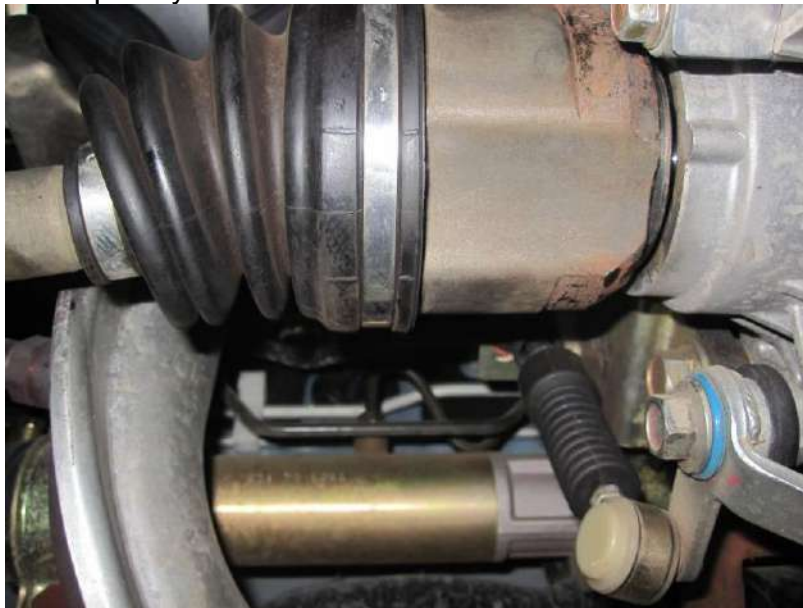
-Push driveshaft completely into the transmission:

Fig. 1-6: Drive shaft mounted

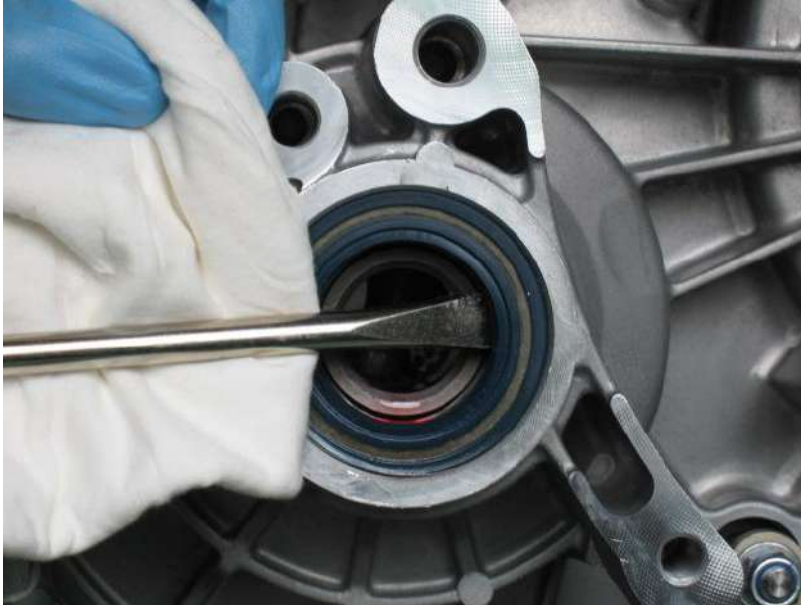
Fig. 2-1: Remove oil seal

- Drain the oil of the transmission (see changing oil filter)
- Remove half shaft
- use a big screwdriver to pinch out the seal. Be careful not to put screwdriver in too deep, otherwise the housing can be damaged by the tip of the screwdriver (see Fig. 2-1)
- Discard the old oil seal

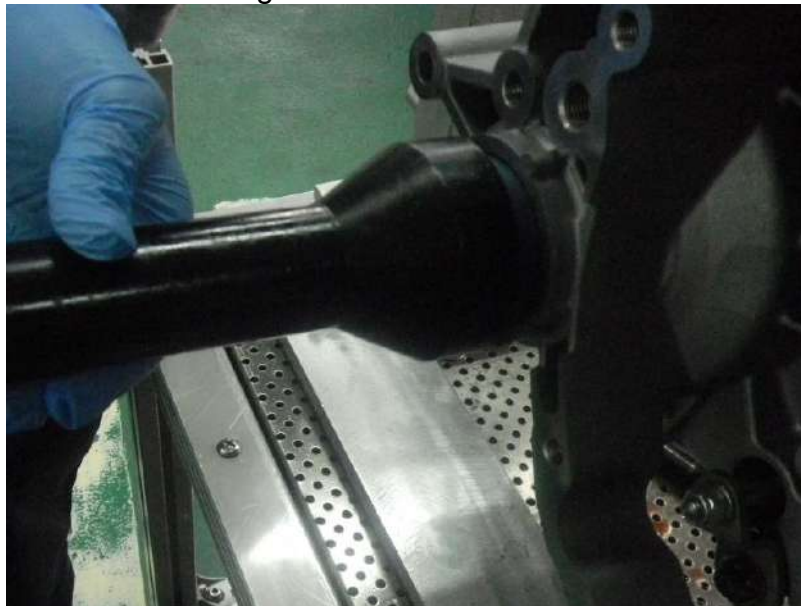
Fig. 2-2: Installing new seal with special tool

- Take a new seal and put it in the housing (see Fig. 2-2)
- Place the special tool (480143) on the seal and use a rubber hammer to knock oil seal into the housing. Hammer it all the way in until no further is possible
- The depth of the oil seal should now be $3\text{mm} \pm 0.3\text{mm}$ from the edge of the housing
- Replace the half shaft if necessary
- Refill transmission according instruction (see 2.1)

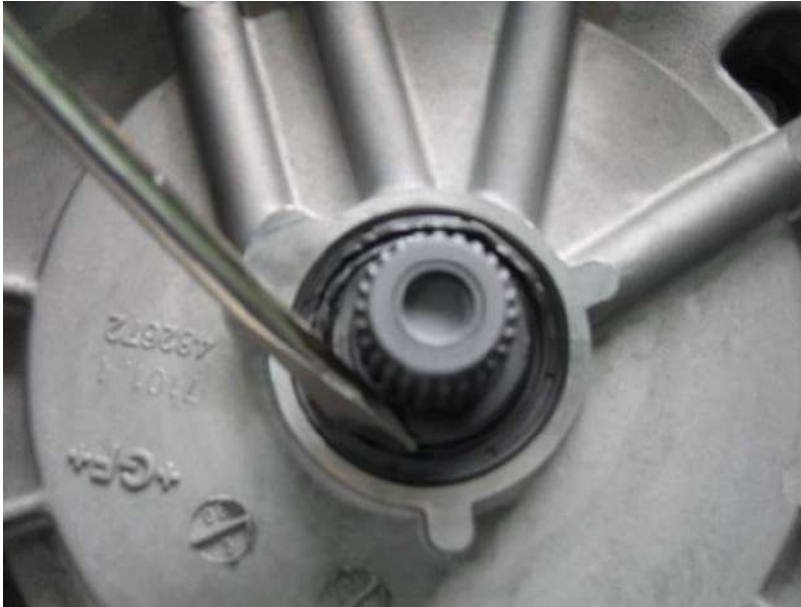
Fig. 3-1: Remove input shaft seal

- Remove the transmission from the car
- Use a big screwdriver to peel out the seal from the transmission (see Fig. 3-1). Peel out the seal from the inside of the seal by going around and around. Be careful not to damage the input shaft
- Discard the old oil seal

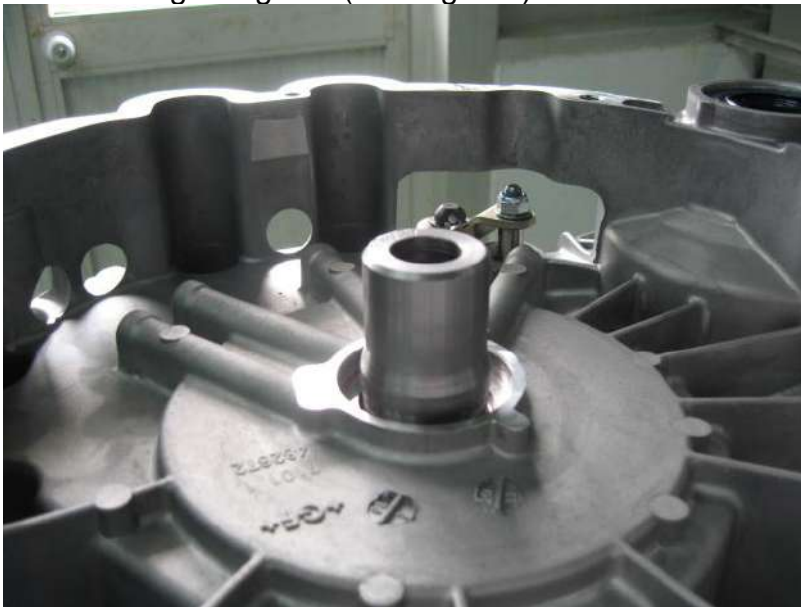
Fig. 3-2: Put special tool on input shaft (480129)

- Place the special guiding tool (480129) on input shaft (see Fig. 3-2)
- Slide a new seal over the guiding tool (see Fig. 3-3)

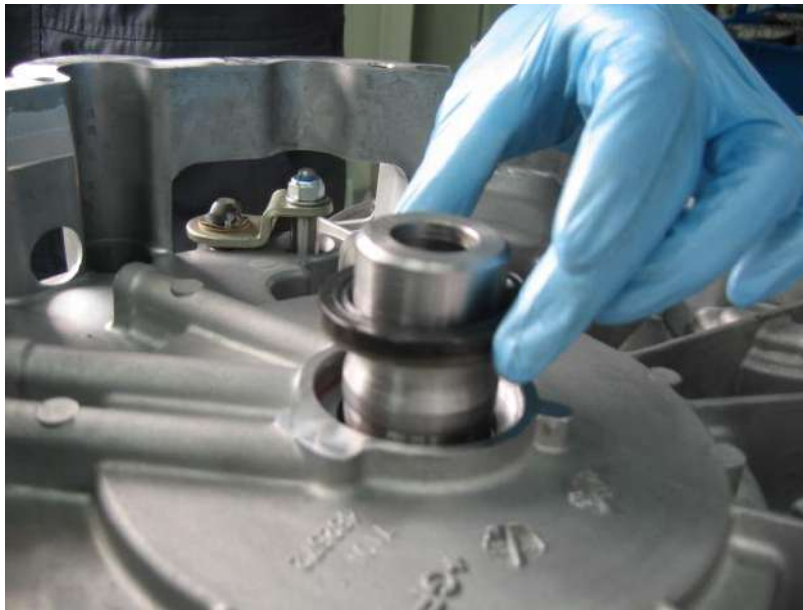
Fig. 3-3: Press the oil seal

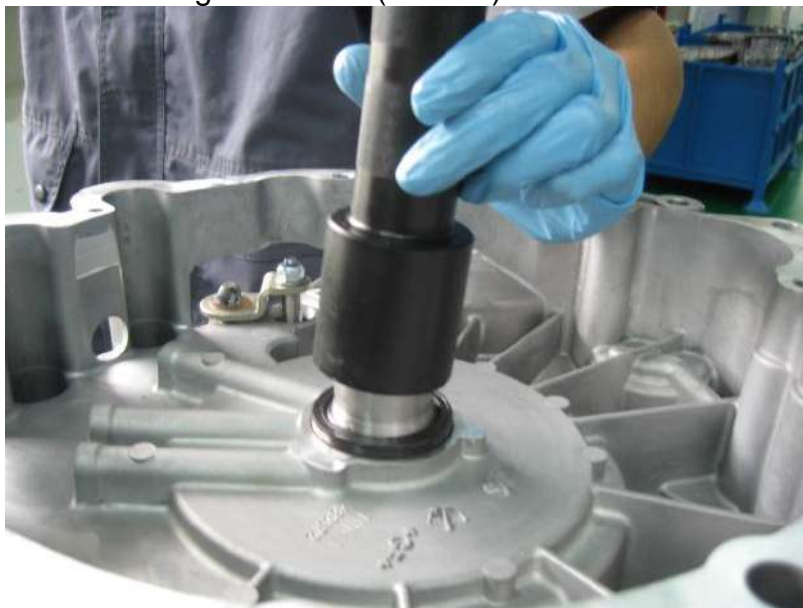
Fig. 3-4: Installing seal by special stamp (480130)

- Place the special stamp tool (480130) on input shaft (see Fig. 3-4)
- Hit the special stamp tool with rubber hammer until no further is possible
- Remove special tools and refit transmission in vehicle
- Refill transmission according instruction (see 2.1)

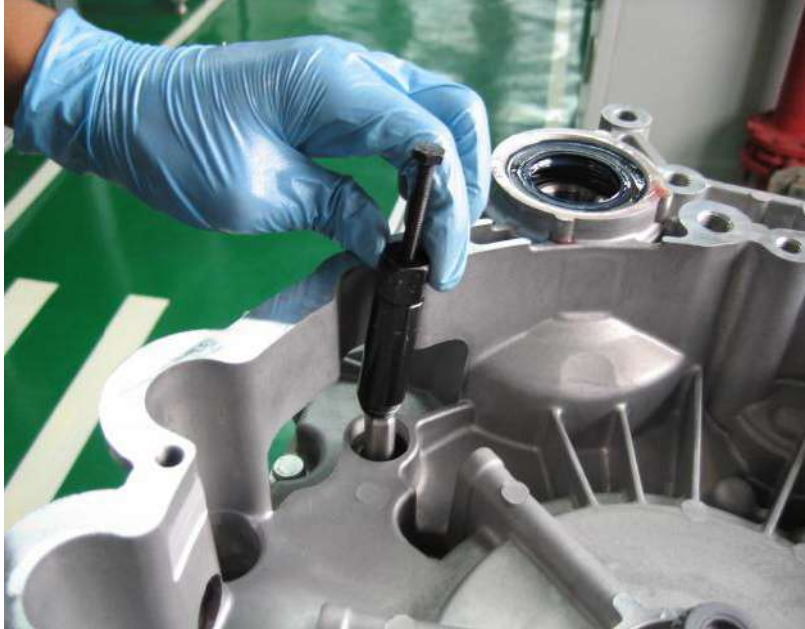
Fig. 4-1: Put special tool (480127) on shaft

- Drain the oil of the transmission (see changing oil filter)
- Remove the transmission from the car
- Remove lever selector shaft
- Place special tool (480127) over the selector shaft (see Fig. 4-1)

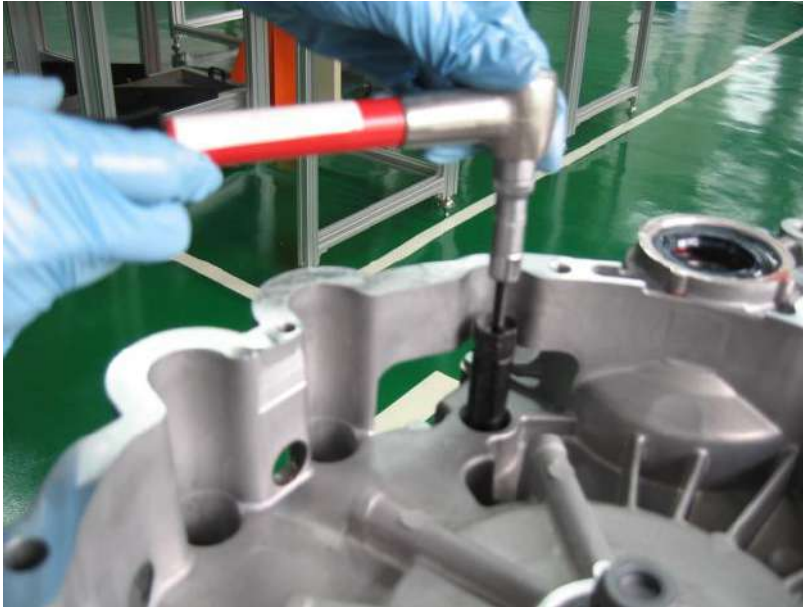
Fig. 4-3: Rotate screw to remove the seal

- Screw in the special tool with wrench. Push on top of the wrench so the tool has the ability to screw itself into the seal (see Fig. 4-2)
- Screw in the screw on top of the special tool to lift out the seal (see Fig. 4-3)
- Discard the seal (see Fig. 4-4)

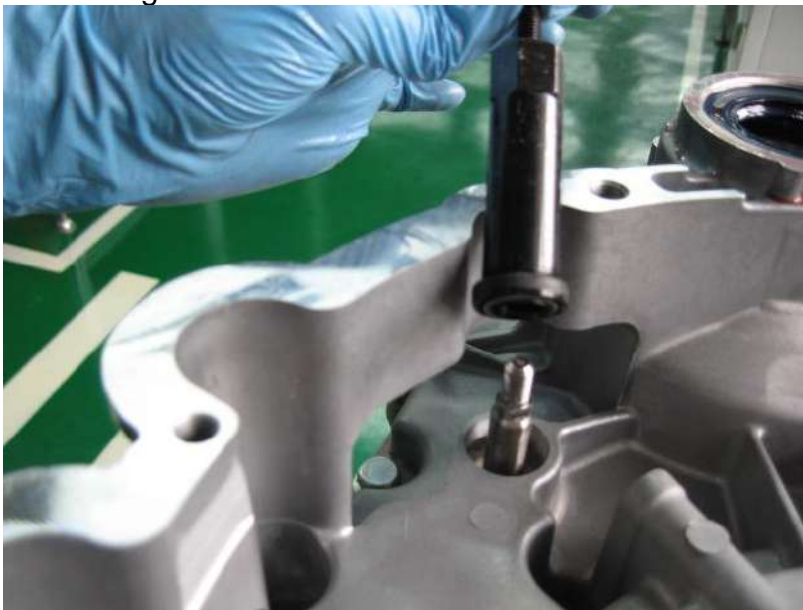
Fig. 4-4: Remove the oil seal

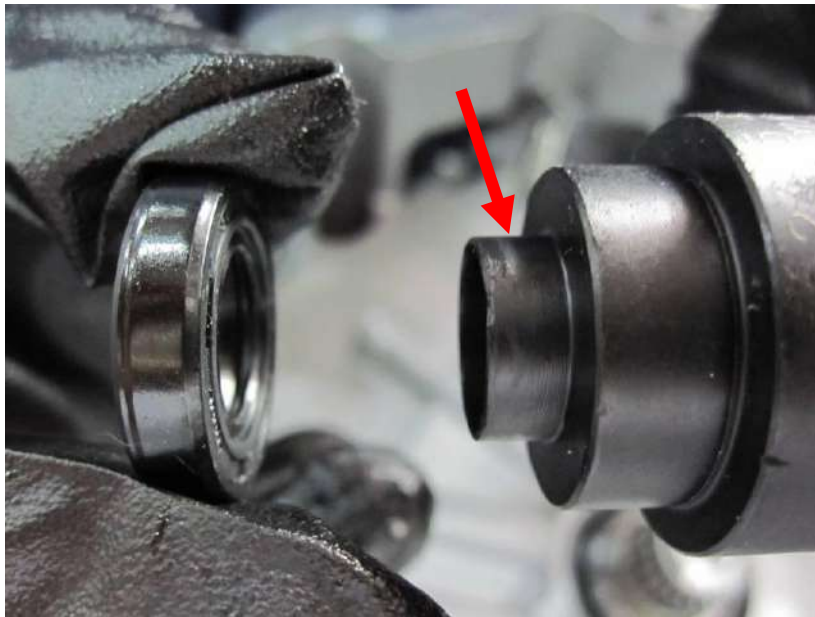
Fig. 4-5: Slide the seal over the special stamp (480125)

- Put some vaseline or grease on the tip of the stamp (480125) (see arrow in Fig. 4-5)
- Take a new seal and slide it over the special stamp (480125) (see Fig. 4-5).
- Place special stamp tool (480125) with seal over the selector shaft and hammer in the seal until no further possible (see Fig. 4-6 and 4-7).
- Pull out the special stamp tool (480125)

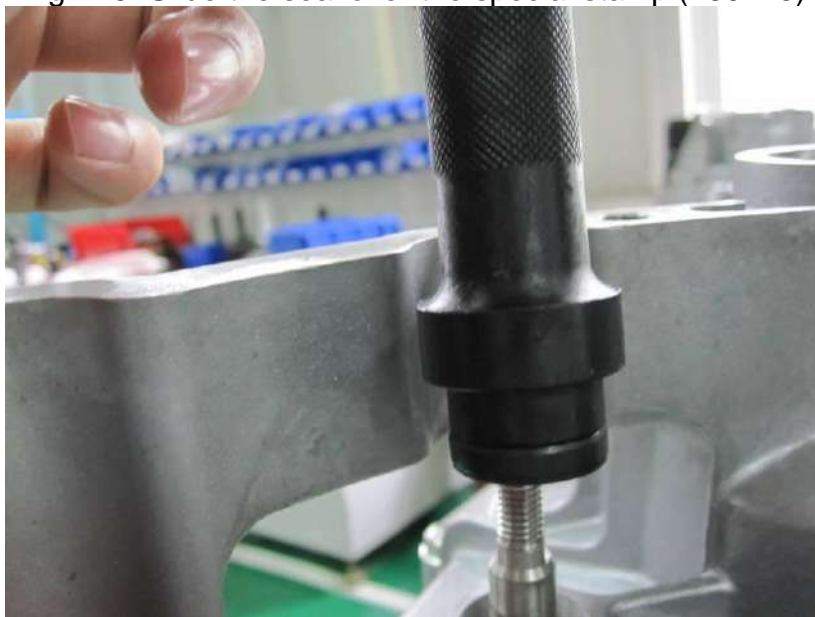
Fig. 4-6: Place special stamp (480125) with seal over the selector shaft

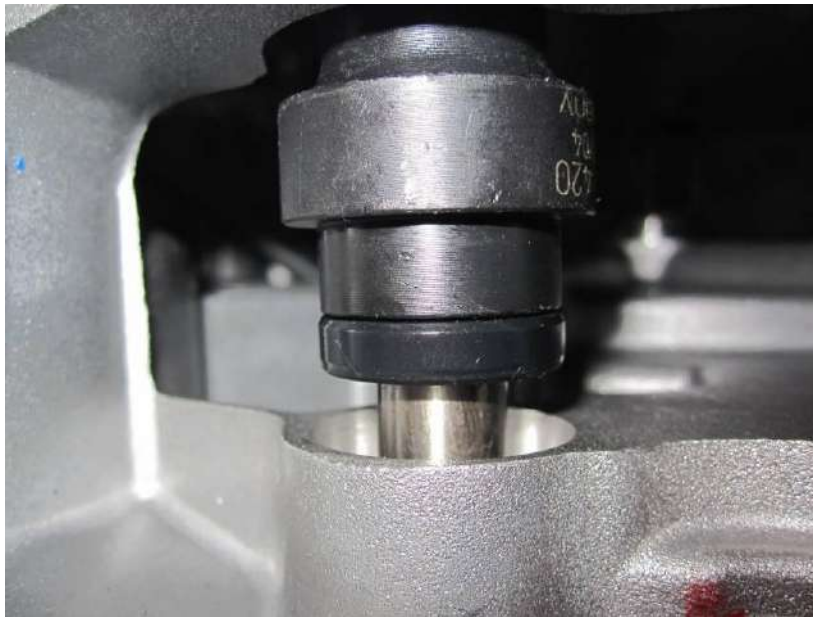
- Fig. 4-7: Hammer down special stamp (480125) with seal till no further is possible
- Remove the stamp while rotating, otherwise there is the possibility the seal comes back out with the stamp
 - Remount the lever selector shaft with new washer (482584) and nut (481329).
 - Tighten the nut with $14.5\text{Nm} \pm 1.5\text{Nm}$
 - Refit transmission in vehicle
 - Refill transmission according instruction (see 2.1)

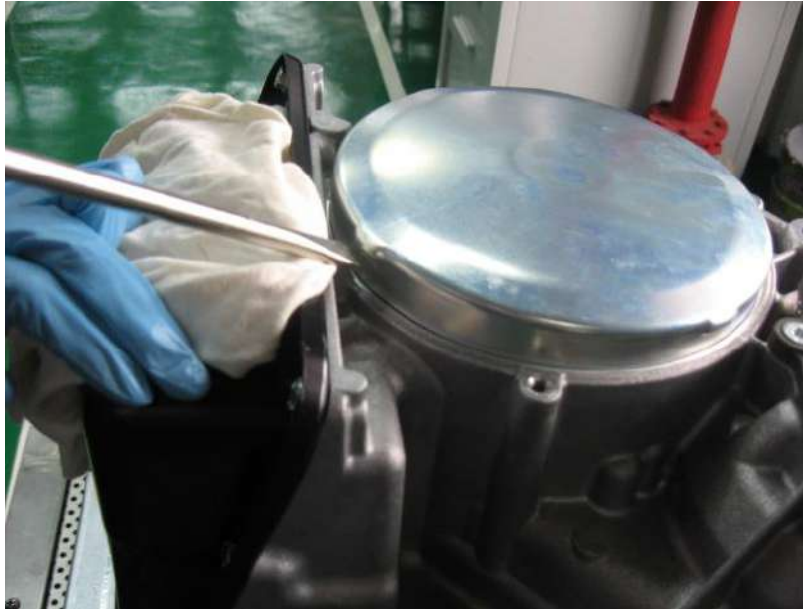
Fig. 5-1: Remove primary cover from transmission

- Drain approx. 1litre of oil out of the transmission (see replacing oil filter)
- The transmission does not need to be removed from the vehicle but may be lowered together with the engine for easier access
- Loosen the three bolts and clips which are fixing the primary cover to the housing.
- Use a screwdriver to lift out the primary cover. Use some cloth to protect the transmission from damage (see Fig. 5-1)
- Remove the big O-ring and discard both O-ring and primary cover
- Take a new O-ring and assemble it
- Replace a new primary cover and fix clips and bolts with a torque of $9.5\text{Nm} \pm 2.5\text{Nm}$
- Refill transmission with 1litre of oil

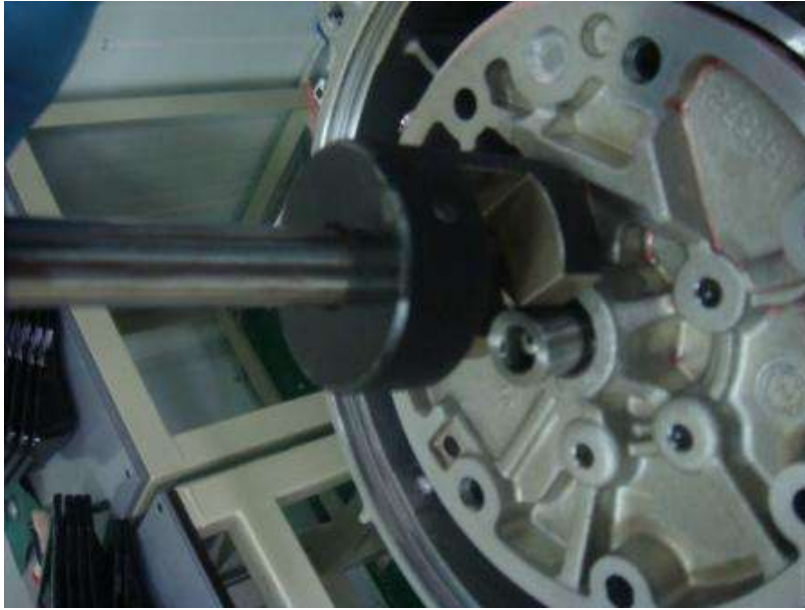
Fig. 6-1: Remove six bolts and place tool (480141)

- Follow the steps to remove the primary cover
- Remove the 6 pump bolts and place special tool (480141) (see Fig. 6-1)
- Pull the sliding part of the tool a few times to lift out the pump (see Fig. 6-2).
- Replace the pump with a new one. Make sure you put 2 new O-rings and 1 plastic snap ring on the new pump. Do not take out the Belle-ville washer and leave it in its correct position which is biggest diameter facing the pump (see Fig. 6-3)
- Put the 6 screws back and tighten with (10Nm +/- 1Nm)
- Follow the steps to close back the primary cover, no need to take new primary cover O-ring and primary cover

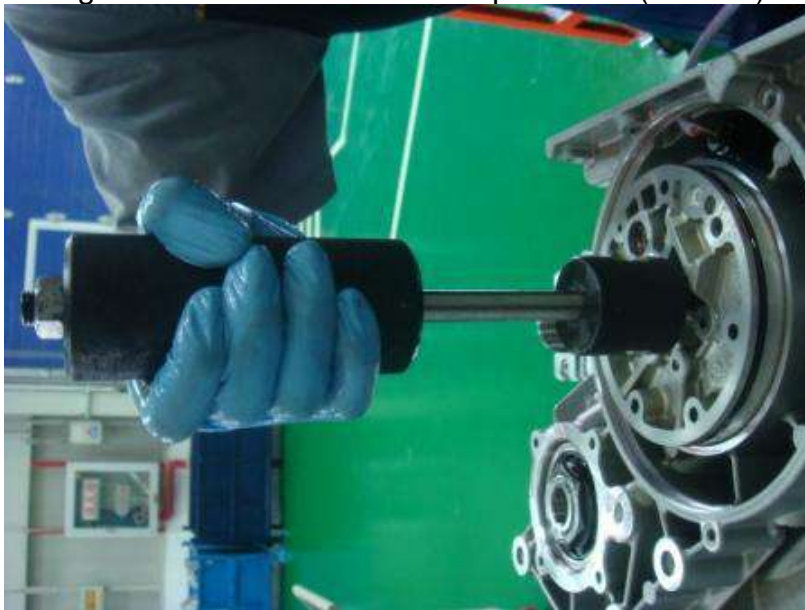
Fig. 6-2: Pull the tool to lift out pump

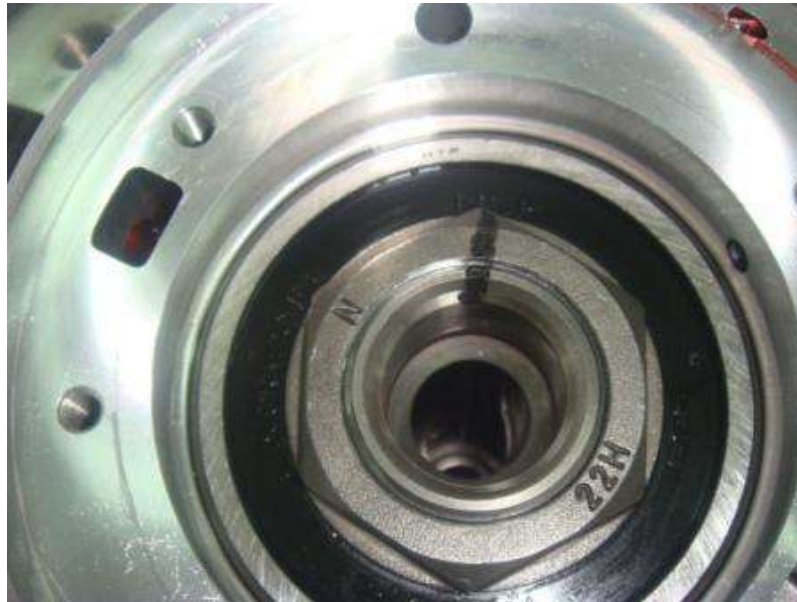
Fig. 7-1: Mark primary nut and shaft

- Follow the steps to remove the oil pump
- Remove Belle-ville washer
- Mark the position of the primary nut on the shaft (see Fig. 7-1)
- Using an air impact wrench with a torque capacity of +/-300Nm, remove the primary nut

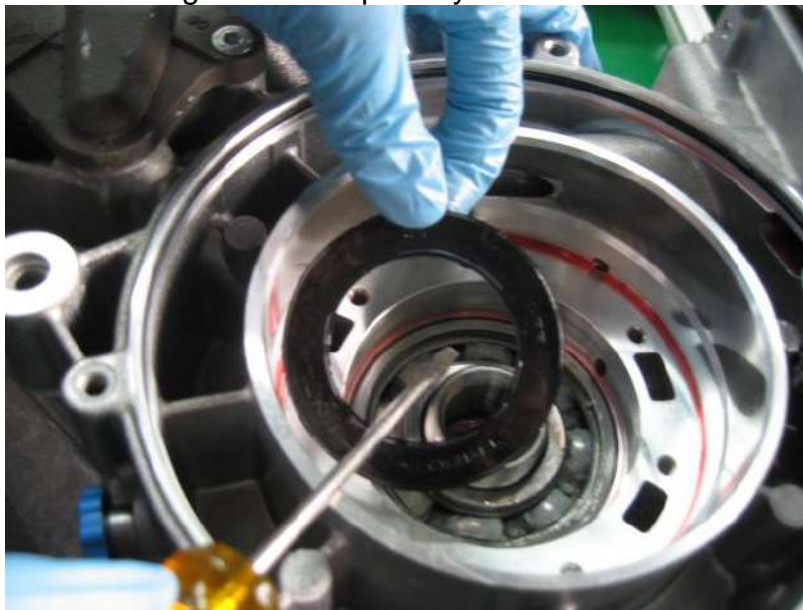
Fig. 7-2: Lever out seal from primary bearing

- Lever out the seal of the primary ball bearing using a small screwdriver (see Fig. 7-2)
- Place the special tool primary plug (480139) (see Fig. 7-3)
- Assemble the bearing puller (480136) underneath the exterior ring of the primary bearing (see Fig. 7-4)

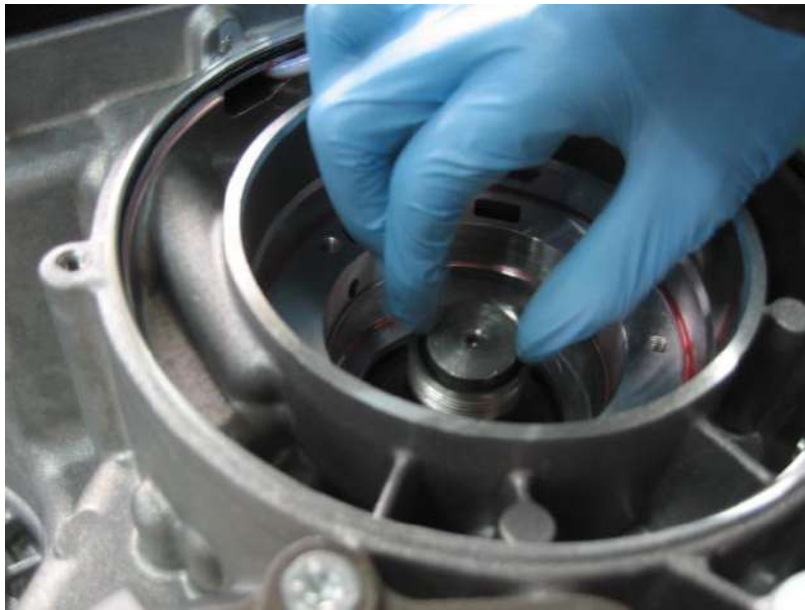
Fig. 7-3: Put special tool on shaft (primary plug 480139)

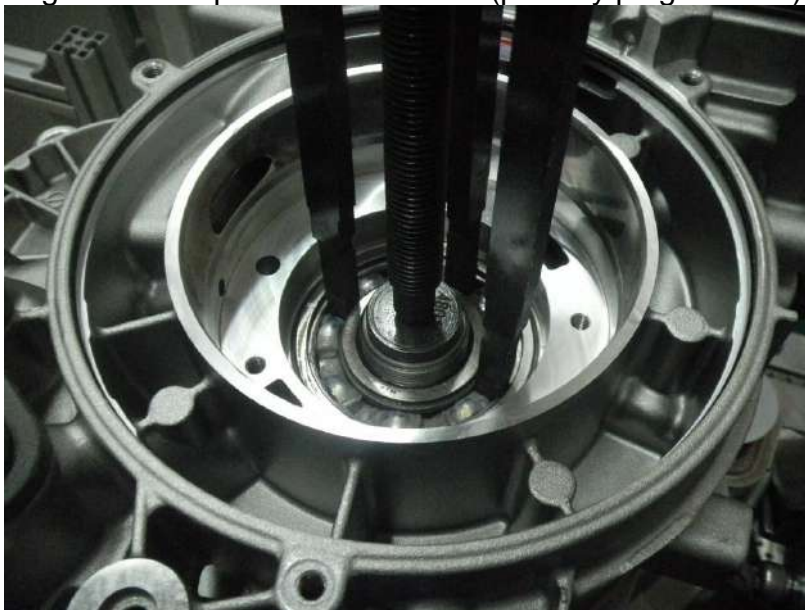
Fig. 7-4: Assemble bearing puller (480136)

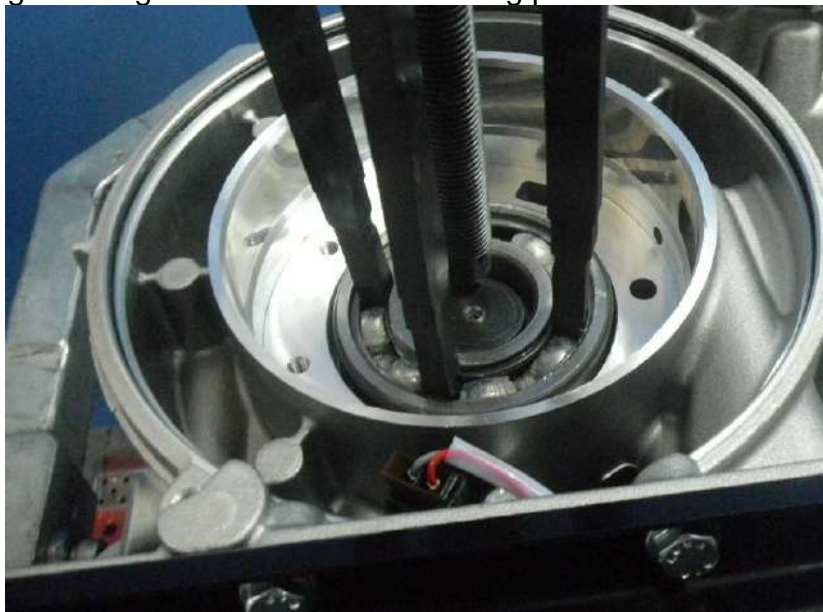
Fig. 7-6: Remove primary bearing

- Remove primary bearing by tightening the centre bolt of the bearing puller (see Fig. 7-5)
- Discard primary bearing, clean primary shaft, clean sealant from threads in oil pump drive shaft and clean oil pump housing (see Fig. 7-6)

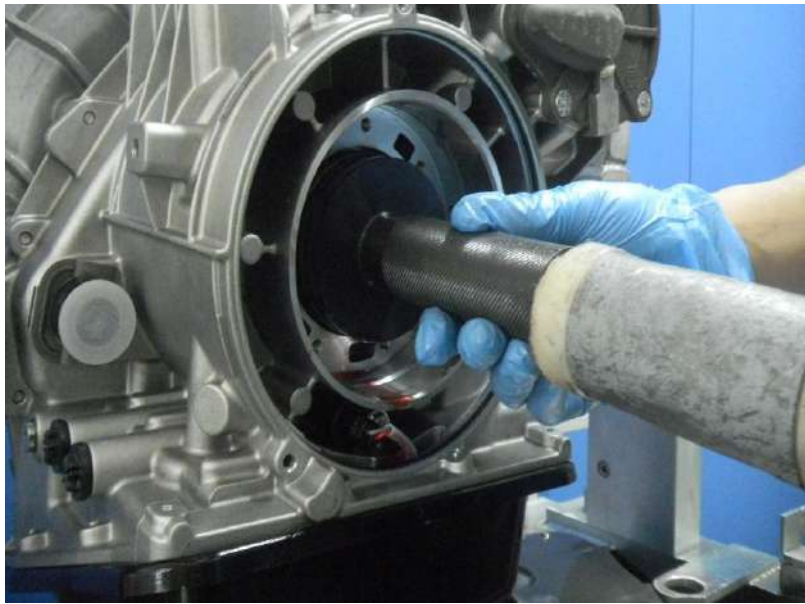
Fig. 7-7: Fit new primary ball bearing

- Place a new bearing on the primary shaft and use special stamp tool (480137 + 480126) to put bearing in. Use rubber hammer and hit until no further possible (see Fig. 7-7)

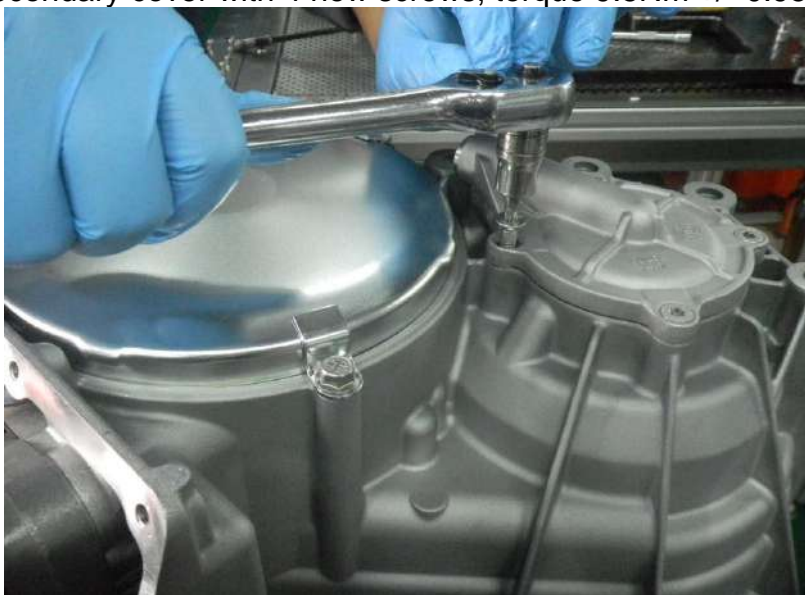
Fig.1 : Take off secondary cover bolt

- The transmission does not need to be removed from the vehicle but may be lowered together with the engine for easier access
- Loosen the four screws and discard screws
- Take off secondary cover, remove the small and bigger O-ring and the center sealing ring
- In case of damaged cover, take a new secondary cover
- Replace new O-rings and sealing ring
- Remove the glue (glue from the sealant screws) gently from the transmission housing
- Tighten the secondary cover with 4 new screws, torque 9.5Nm +/- 0.95Nm

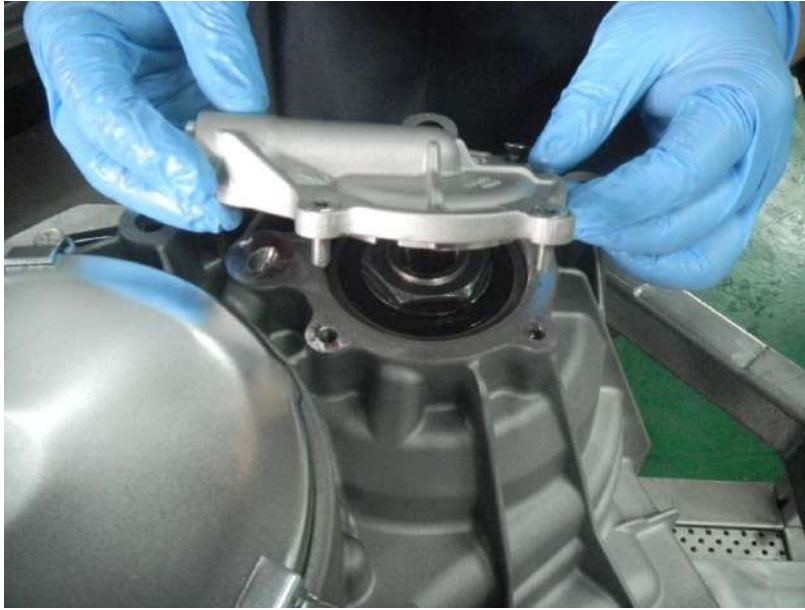
Fig.2 : remove secondary cover

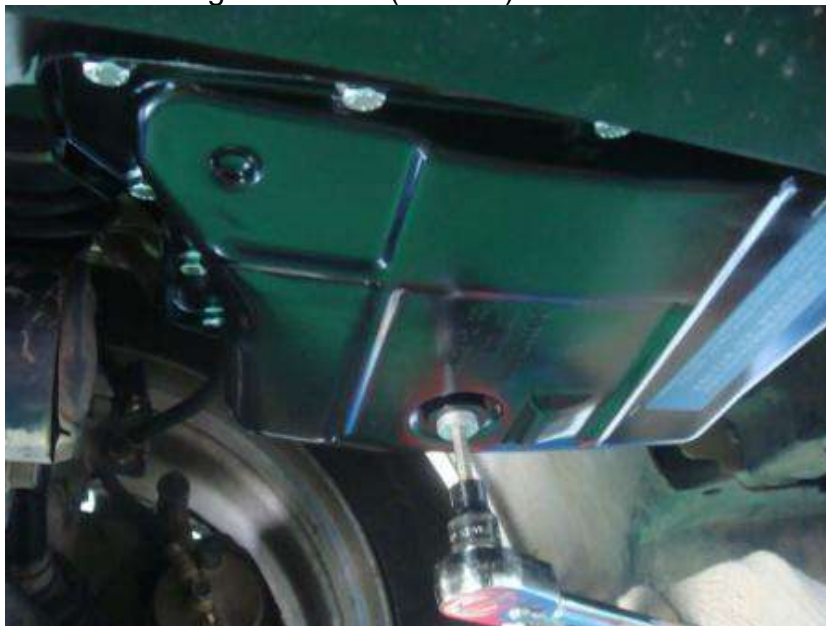
Fig. 9-1 Remove oil drain plug

- Drain the oil by removing the oil drain plug (see Fig. 9-1)
- Let all oil drip out, discard old drain plug
- Remove oil pan by unscrewing all 13 screws from the oil pan (see Fig. 9-2)
- Discard the oil pan gasket and oil pan
- Take new oil pan and gasket
- Fix oil pan with new gasket by tightening the screws according to Fig. 9-3 with 9.5Nm +/- 1Nm
- Refill transmission according instruction (see 2.1).

- Drain the oil by removing the oil drain plug (see Fig. 9-1)
- Let all oil drip out, discard old drain plug
- Refit new drain plug and tighten with 11Nm +/-1Nm
- Remove oil pan by unscrewing all 13 screws from the oil pan (see Fig. 9-2)
