PUNCH Powertrain

Continuously Variable Transmission

Service Manual VT2-VT3 for Haima ZZ

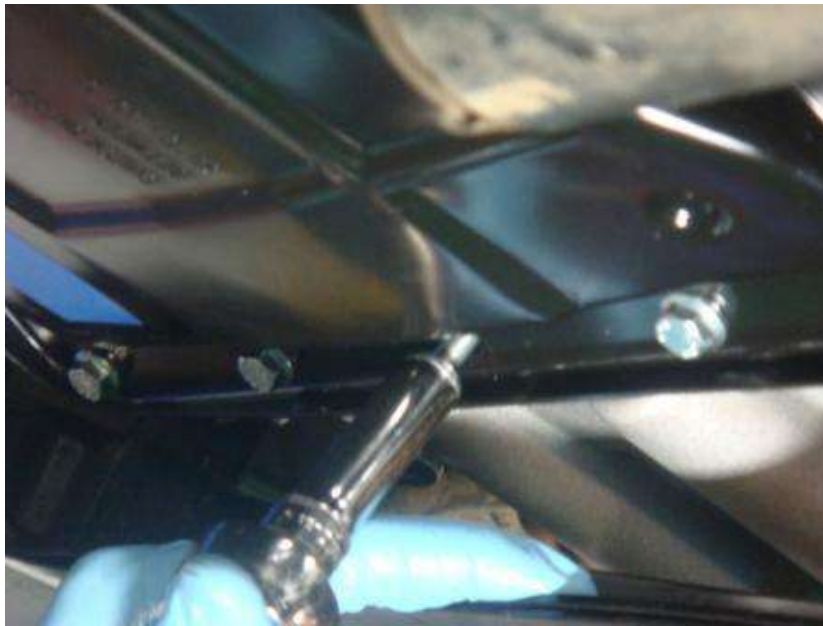
Fig. 9-2 Removing the oil pan

- Drain the oil by removing the oil drain plug (see Fig. 9-1)
- Let all oil drip out, discard old drain plug
- Remove oil pan by unscrewing all 13 screws from the oil pan (see Fig. 9-2)
- Discard the oil pan gasket and oil pan
- Take new oil pan and gasket
- Fix oil pan with new gasket by tightening the screws according to Fig. 9-3 with 9.5Nm +/- 1Nm
- Refill transmission according instruction (see 2.1).

- Drain the oil by removing the oil drain plug (see Fig. 9-1)
- Let all oil drip out, discard old drain plug
- Refit new drain plug and tighten with 11Nm +/-1Nm
- Remove oil pan by unscrewing all 13 screws from the oil pan (see Fig. 9-2)

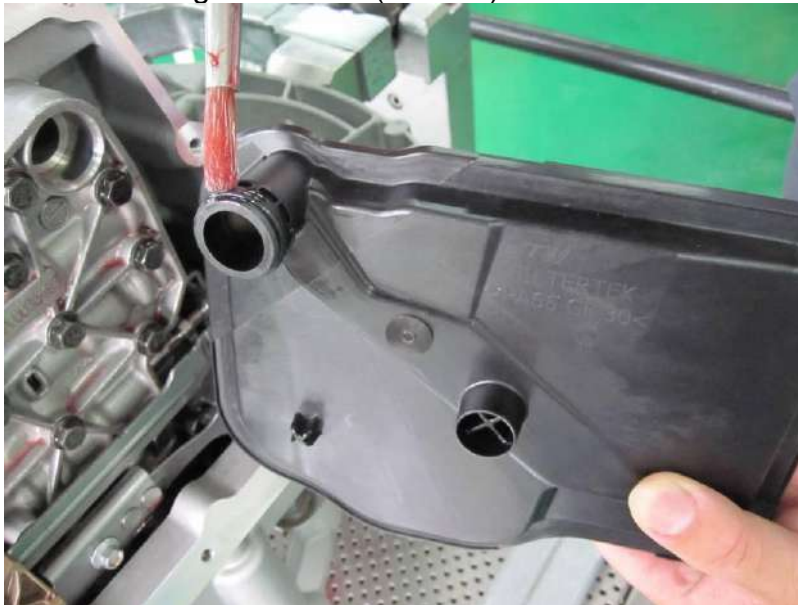
Fig. 10-1: Lubricate the O-ring

- Discard the oil pan gasket
- Remove the oil filter by pulling it gently, discard oil filter
- Take new filter with O-ring and lubricate the O-ring with clean ESSO EZL799(A) (see Fig. 10-1)
- Press in gently the new oil filter and position correctly (centre hole of oil filter should match centre bolt of hydraulic unit) (see Fig. 10-2)
- Clean magnet and surface of oil pan and place a new oil pan gasket
- Place oil pan with new gasket in place and tighten the 13 screws according to Fig. 9-3 with 9.5Nm +/- 1Nm
- Refill transmission according instruction (see 2.1)

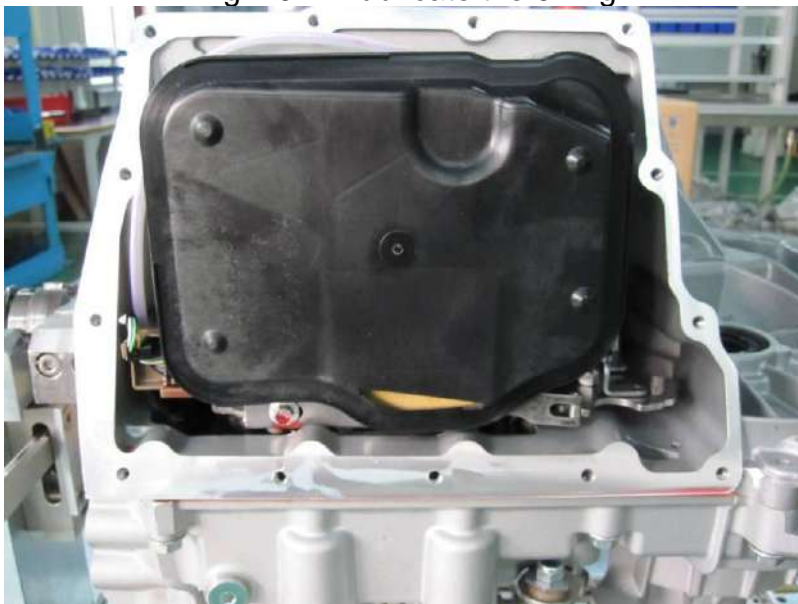
Fig. 10-2: Fix oil filter in position

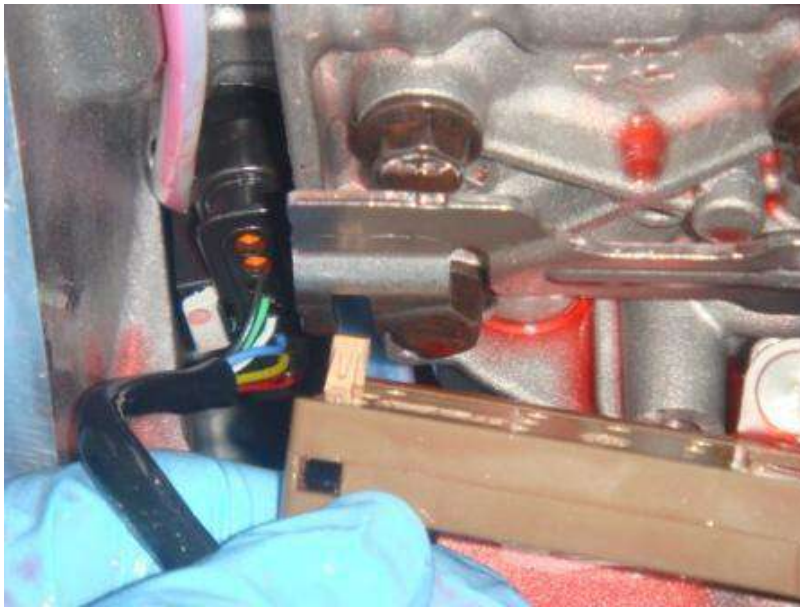
Fig. 11-4: Pin locked in dedicated space of the metal slide

- Take a new drive mode sensor, connect the connector to the main cable harness and lock it by pushing the gray lock button
- Place drive mode sensor against the metal slide, with the pin on the back of the sensor locked in the dedicated space on the slide (see Fig. 11-4)

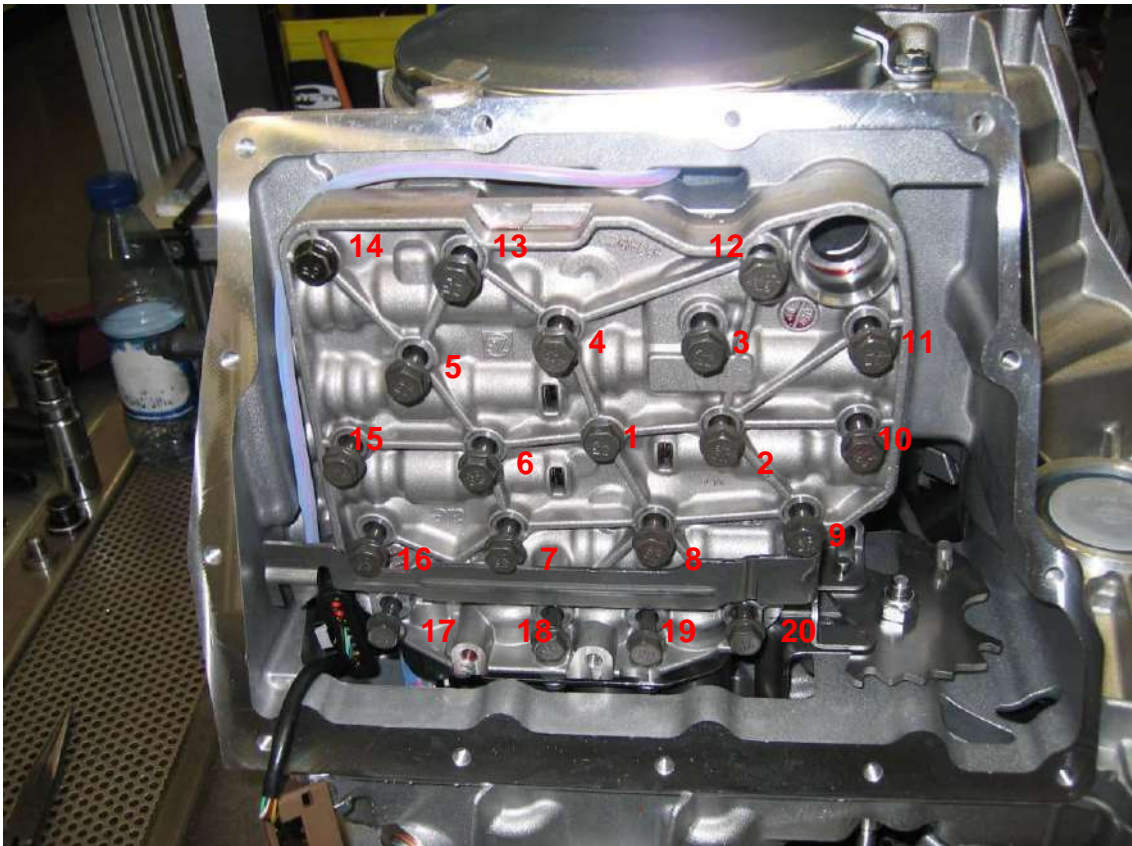
Fig. 12-1: Order of the bolts

- Follow steps to remove the drive mode sensor
- Follow the sequence on Fig. 12-1 in reverse order 20-19-18-17-16-15-14-13-12-11-10-9-8-7-6-5-4-3-2-1 to unscrew all hydraulic unit bolts

- Place all screws of hydraulic unit, except the upper left one and tighten with 11Nm +/- 1Nm in sequence 1-2-3-4-5-6-7-8-9-10-11-12-13-14-15-16-17-18-19-20 on Fig. 11-1 When arriving at the upper left one, take out special tool and replace with screw and continue until screw 20.

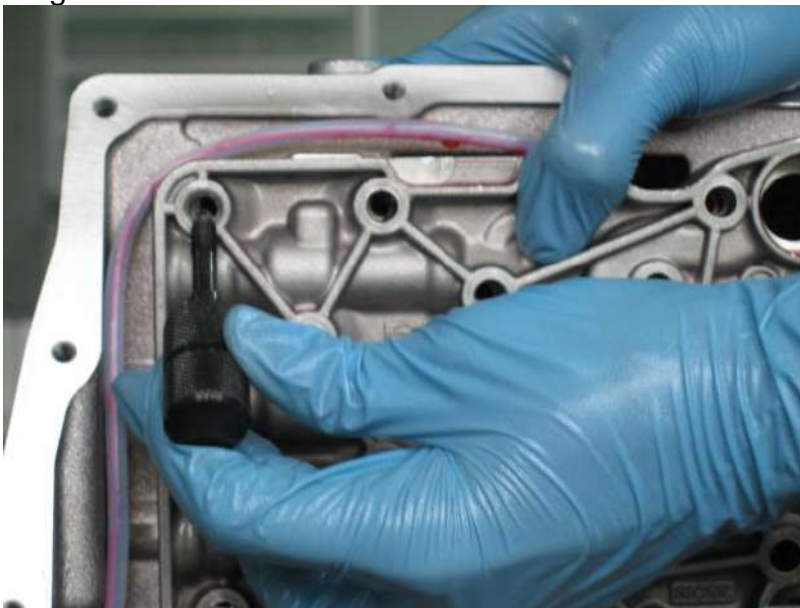
Fig. 12-6: Special alignment (480142) tool for hydr. unit

- Place the center screw and hand tighten it
- Place the special alignment tool (480142) on the top left screw hole and screw it in (see Fig. 12-6)
- Push the speed sensor cable behind the upper left corner of the hydraulic unit (see Fig. 12-6)

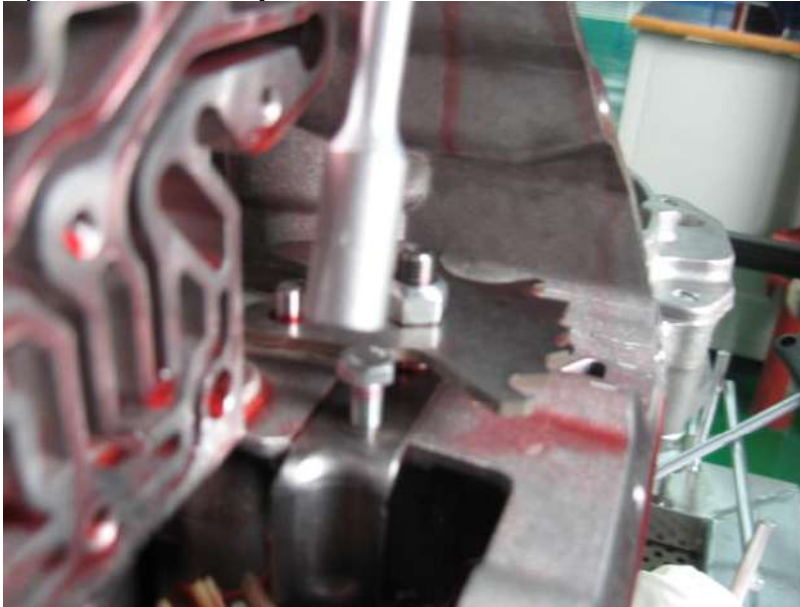
Fig. 13-1: Loosen bolt bracket output speed sensor

- Follow steps to remove the hydraulic unit
- Loosen bolt bracket output speedsensor and discard bolt (see Fig. 13-1)
- Slide out the bracket, there is a dedicated sleeve in the selector shaft! (see Fig. 13-2)
- Disconnect cable from speedsensor with long flat nose pliers (see Fig. 13-3)
- Remove sensor from bracket by unscrewing bolt
- Discard sensor and/or bracket

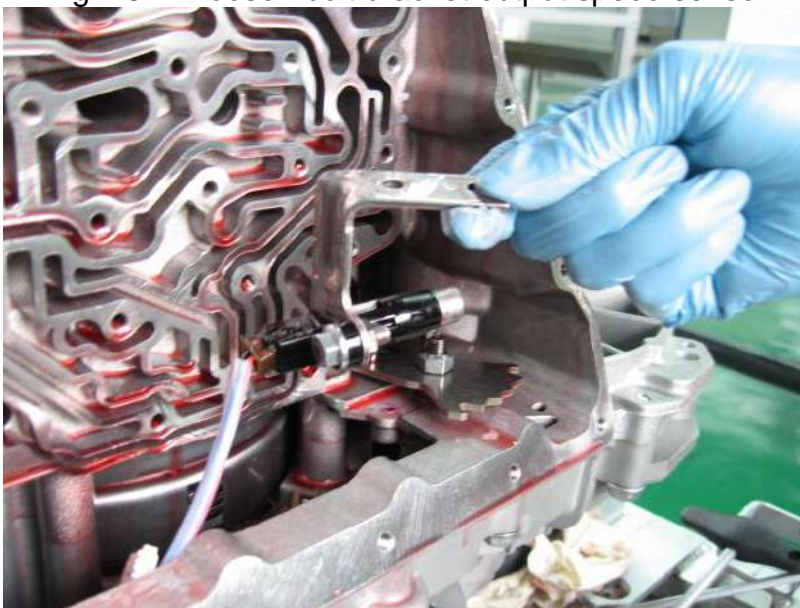
Fig. 13-2: Bracket output speed sensor

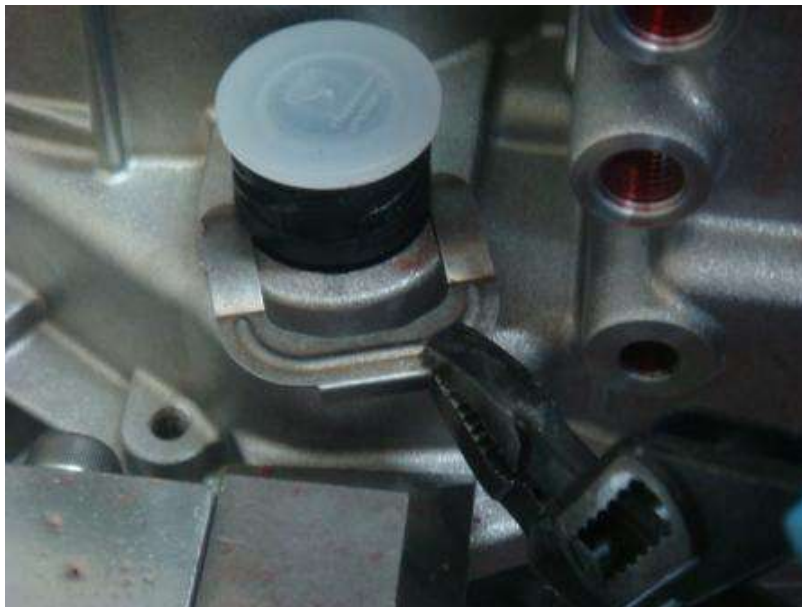
Fig. 15-1: Remove the clip from the main connector

- Follow steps to remove hydraulic unit
- Disconnect output speed sensor
- Disconnect the car cable harness connector from the main connector on the transmission
- Remove the clip with pliers and push the main connector into the transmission (see Fig. 15-1, 15-2)
- The drive mode sensor connector is clipped on the transmission, loosen that one first (see Fig. 15-3)
- Remove the complete cable harness from the transmission and discard
- Take new cable harness and put into transmission
- The main connector has a sleeve which should fit over the securing key on Fig. 15-4, 15-5
- The use of a 45deg angled nose pliers can be helpful to fit in the main connector
- Push clip back on main connector
- Push drive mode sensor connector on the transmission (see Fig. 15-6)
- Connect the output speed sensor
- Follow steps to place back the hydraulic unit

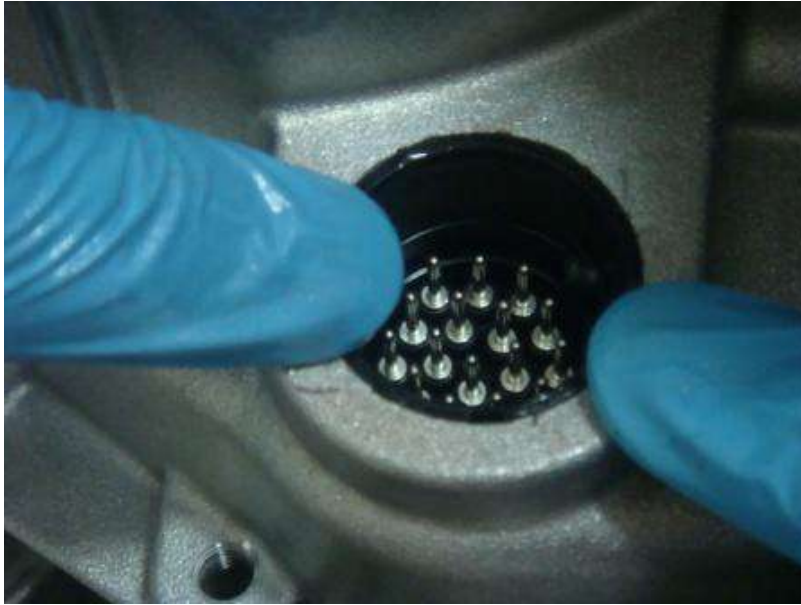
Fig. 15-2: Push main connector into the transmission

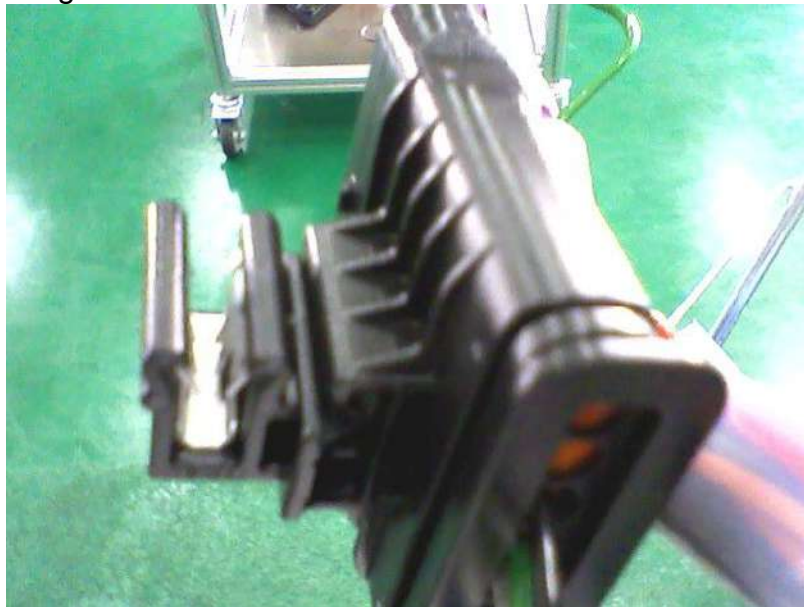
Fig. 15-3: Remove drive mode sensor connector from transmission

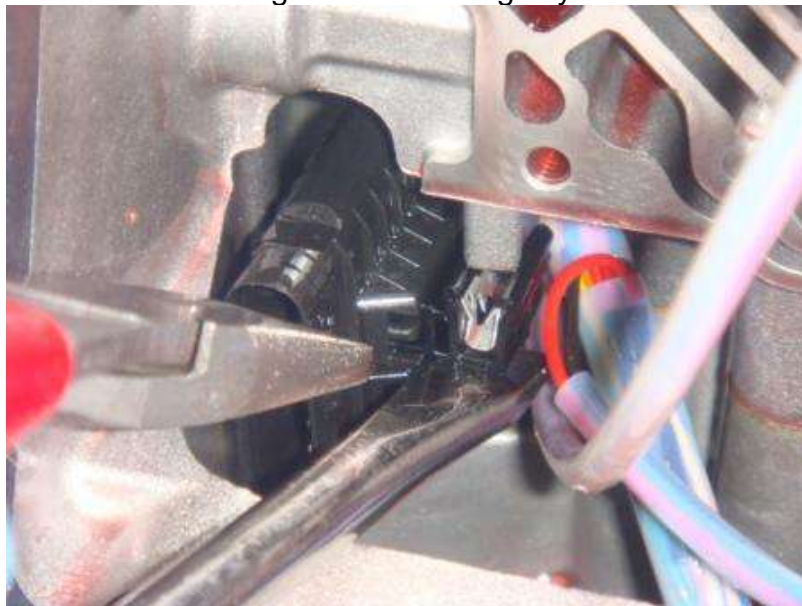
Fig. 15-6: Push drive mode sensor connector on the transmission

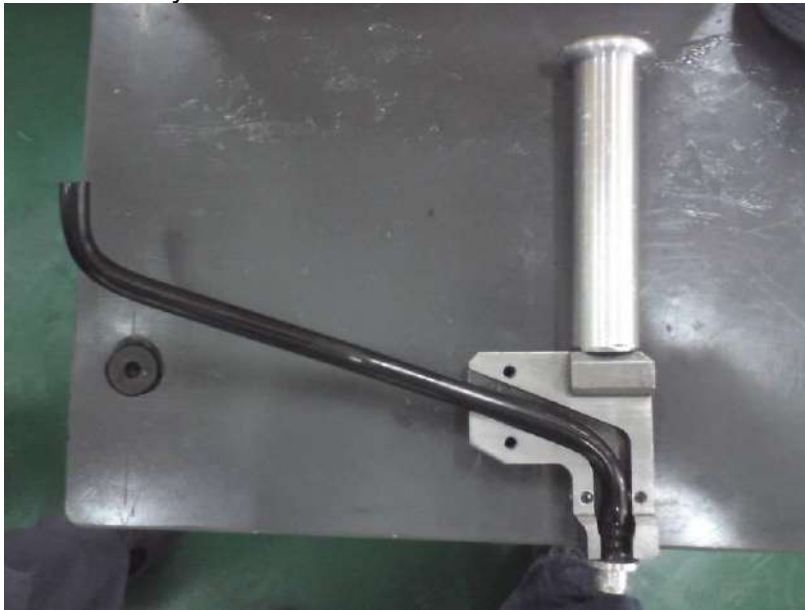
Fig. 16-1: Place the new breather pipe into the assembly tool

- Place the new breather pipe (483114) into the special tool (480140), see Fig. 16-1. Put a little amount of Vaseline on the Aluminum piece of the breather pipe.
- Place tool and breather pipe onto the transmission housing so the pipe runs about parallel with the transmission, Fig. 16-2. Hammer down gently the breather pipe into the transmission house till the end by using a plastic hammer on top of the special tool.
- Put the plastic clip (482253) around the pipe.
- Put the pins of the plastic clip thru the hole of the metal clip (481456).
- Push the metal clip firmly (till the end) onto the ridge of the transmission house.
- Slide the breather cap (483117) complete over the top of the breather pipe. Fig. 16-3
- Replace airbox and battery if needed.

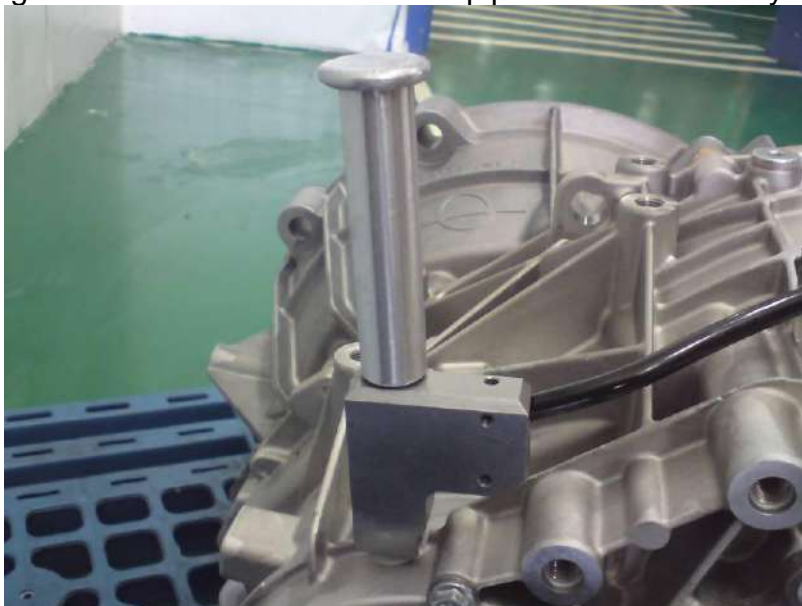
Fig. 16-2: Hammer down the tool till the end with plastic hammer

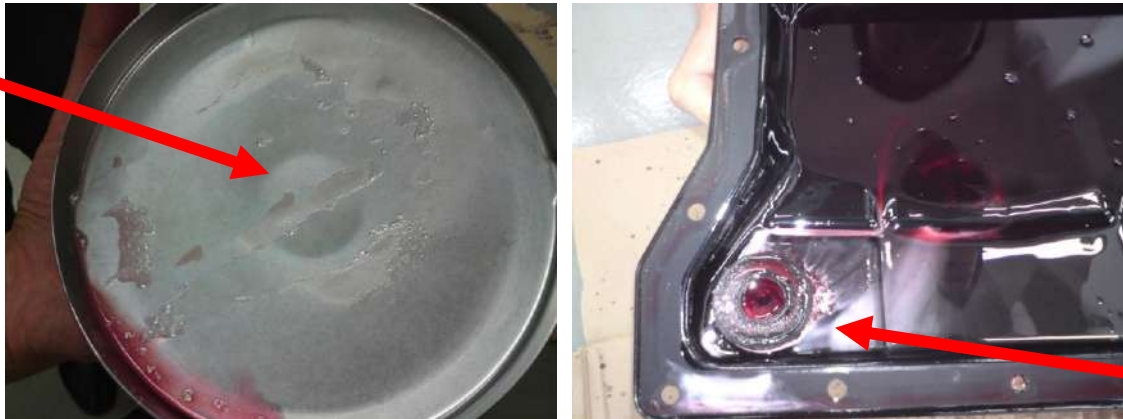
Drain the oil and remove oil pan and primary cover:

If the inside of primary cover and oil pan shows white stuff inside, than it is fully clear the transmission has been contaminated with water or other oil or liquid.
